Contract #: 04-0120F4Cty: SF/ALA Rte: 80 PM: 13.2/13.9File #: 69.28**WELDING INSPECTION REPORT****Resident Engineer:** Pursell, Gary**Address:** 333 Burma Road**City:** Oakland, CA 94607**Report No:** WIR-000751**Date Inspected:** 30-Oct-2007**Project Name:** SAS Superstructure**OSM Arrival Time:** 630**Prime Contractor:** American Bridge/Fluor Enterprises, a JV**OSM Departure Time:** 1530**Contractor:** Zhenhua Port Machinery Company, Ltd (ZPMC), Changxing Island **Location:** Changxing Island**CWI Name:** Fu Guo Gan**CWI Present:** Yes No**Inspected CWI report:** Yes No N/A**Rod Oven in Use:** Yes No N/A**Electrode to specification:** Yes No N/A**Weld Procedures Followed:** Yes No N/A**Qualified Welders:** Yes No N/A**Verified Joint Fit-up:** Yes No N/A**Approved Drawings:** Yes No N/A**Approved WPS:** Yes No N/A**Delayed / Cancelled:** Yes No N/A**Bridge No:** 34-0006**Component:** OBG Closed Rib Trail**Summary of Items Observed:**

Caltrans Quality Assurance (QA) Inspector, Larry Viars was present to observe the dimensional testing of Orthotropic Box Girder (OBG) Mock-up closed rib trial, for the San Francisco Oakland Bay Self Anchored Suspension Bridge, at Zhenhua Port Machine

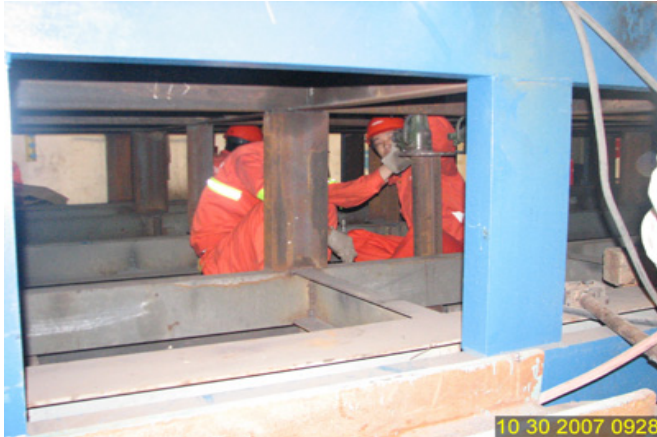
Caltrans QA Inspector monitored welding parameters and weld joint fit up of Orthotropic Box Girders (OBG) closed rib weld trial. Measurements were taken prior to tack welding to ensure a fit-up of .25 mm. If the root gap exceeded .25 mm ZPMC personnel placed a jack below the deck plate adjacent to close rib tacks to achieve the fit up. The following picture shows ZPMC personnel removing decreasing gap with the jack prior to tack welding.
